Kootenai Development Corporation

Flyway Property

Final Completion of Work Report

December 2004

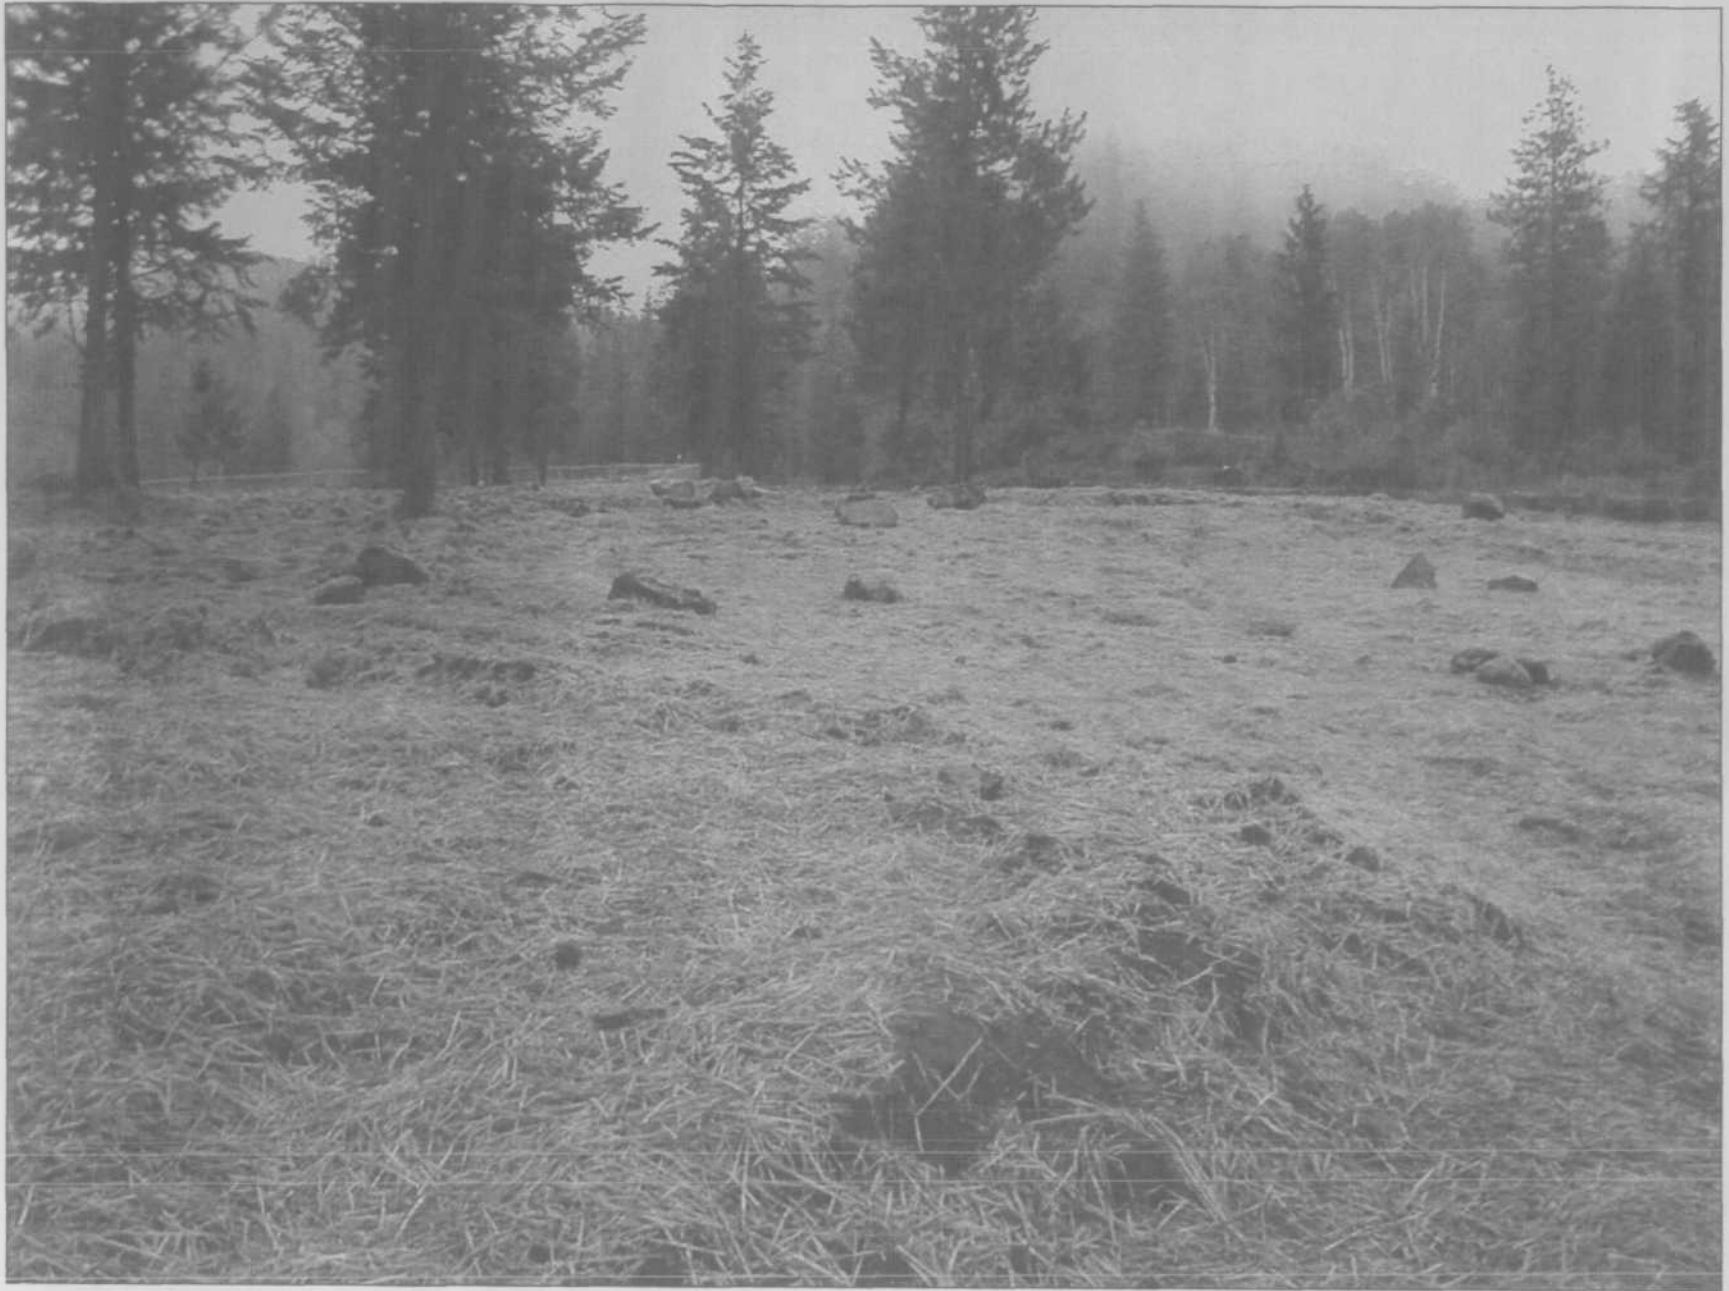
Flyway Site - Large Excavated Area Covered with Straw

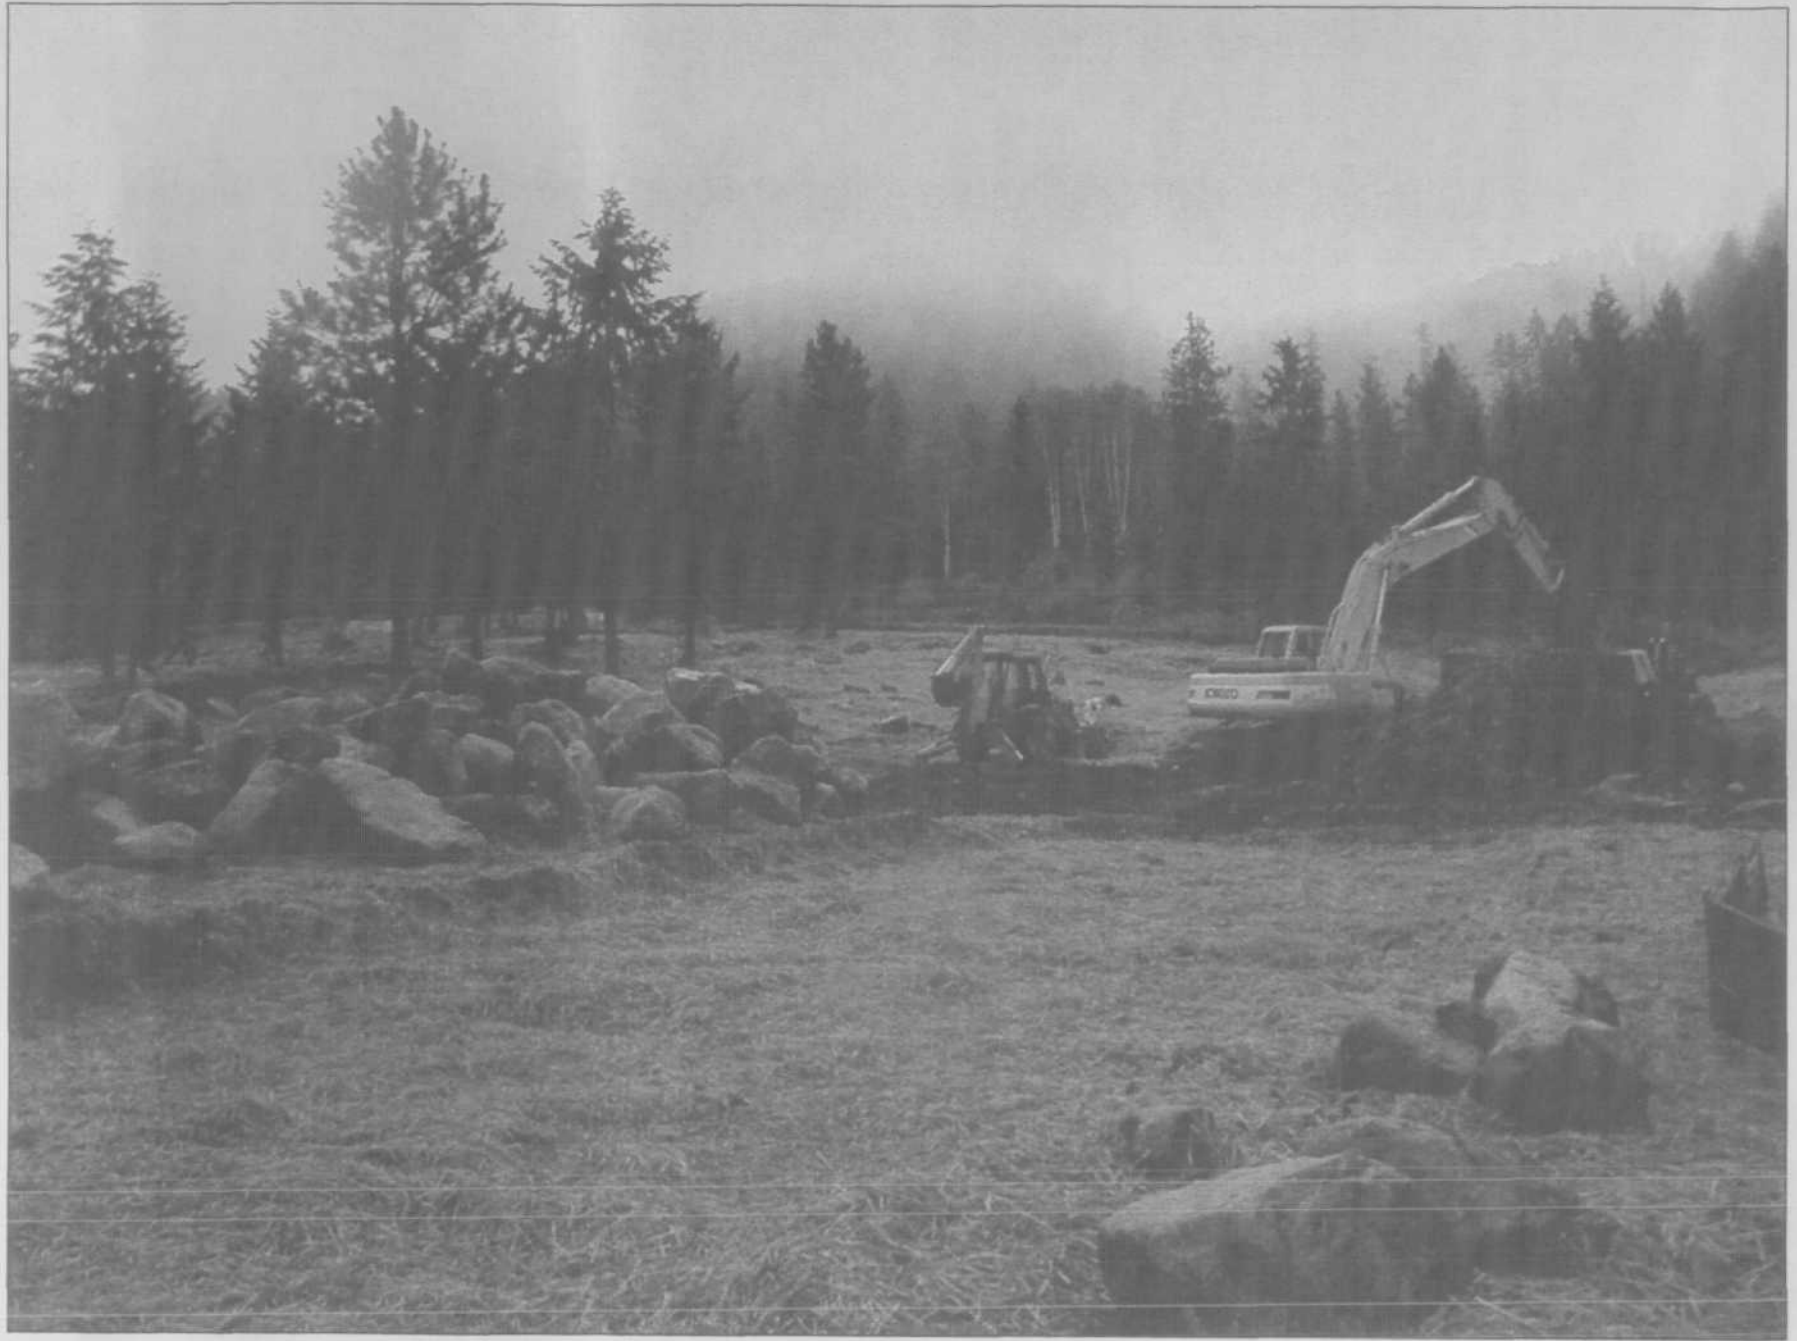
Flyway Site - Boulders Collected from Site and used for Riprap

After the site was backfilled and graded, the riverbank slope was stabilized by placing silt fence and straw bales at the top of the slope. Additionally, rock that was collected from the site was placed along the river's edge. The rock (riprap) extended 4 feet below high water mark and 2 feet above. The extent of riprap placement was approved by EPA.

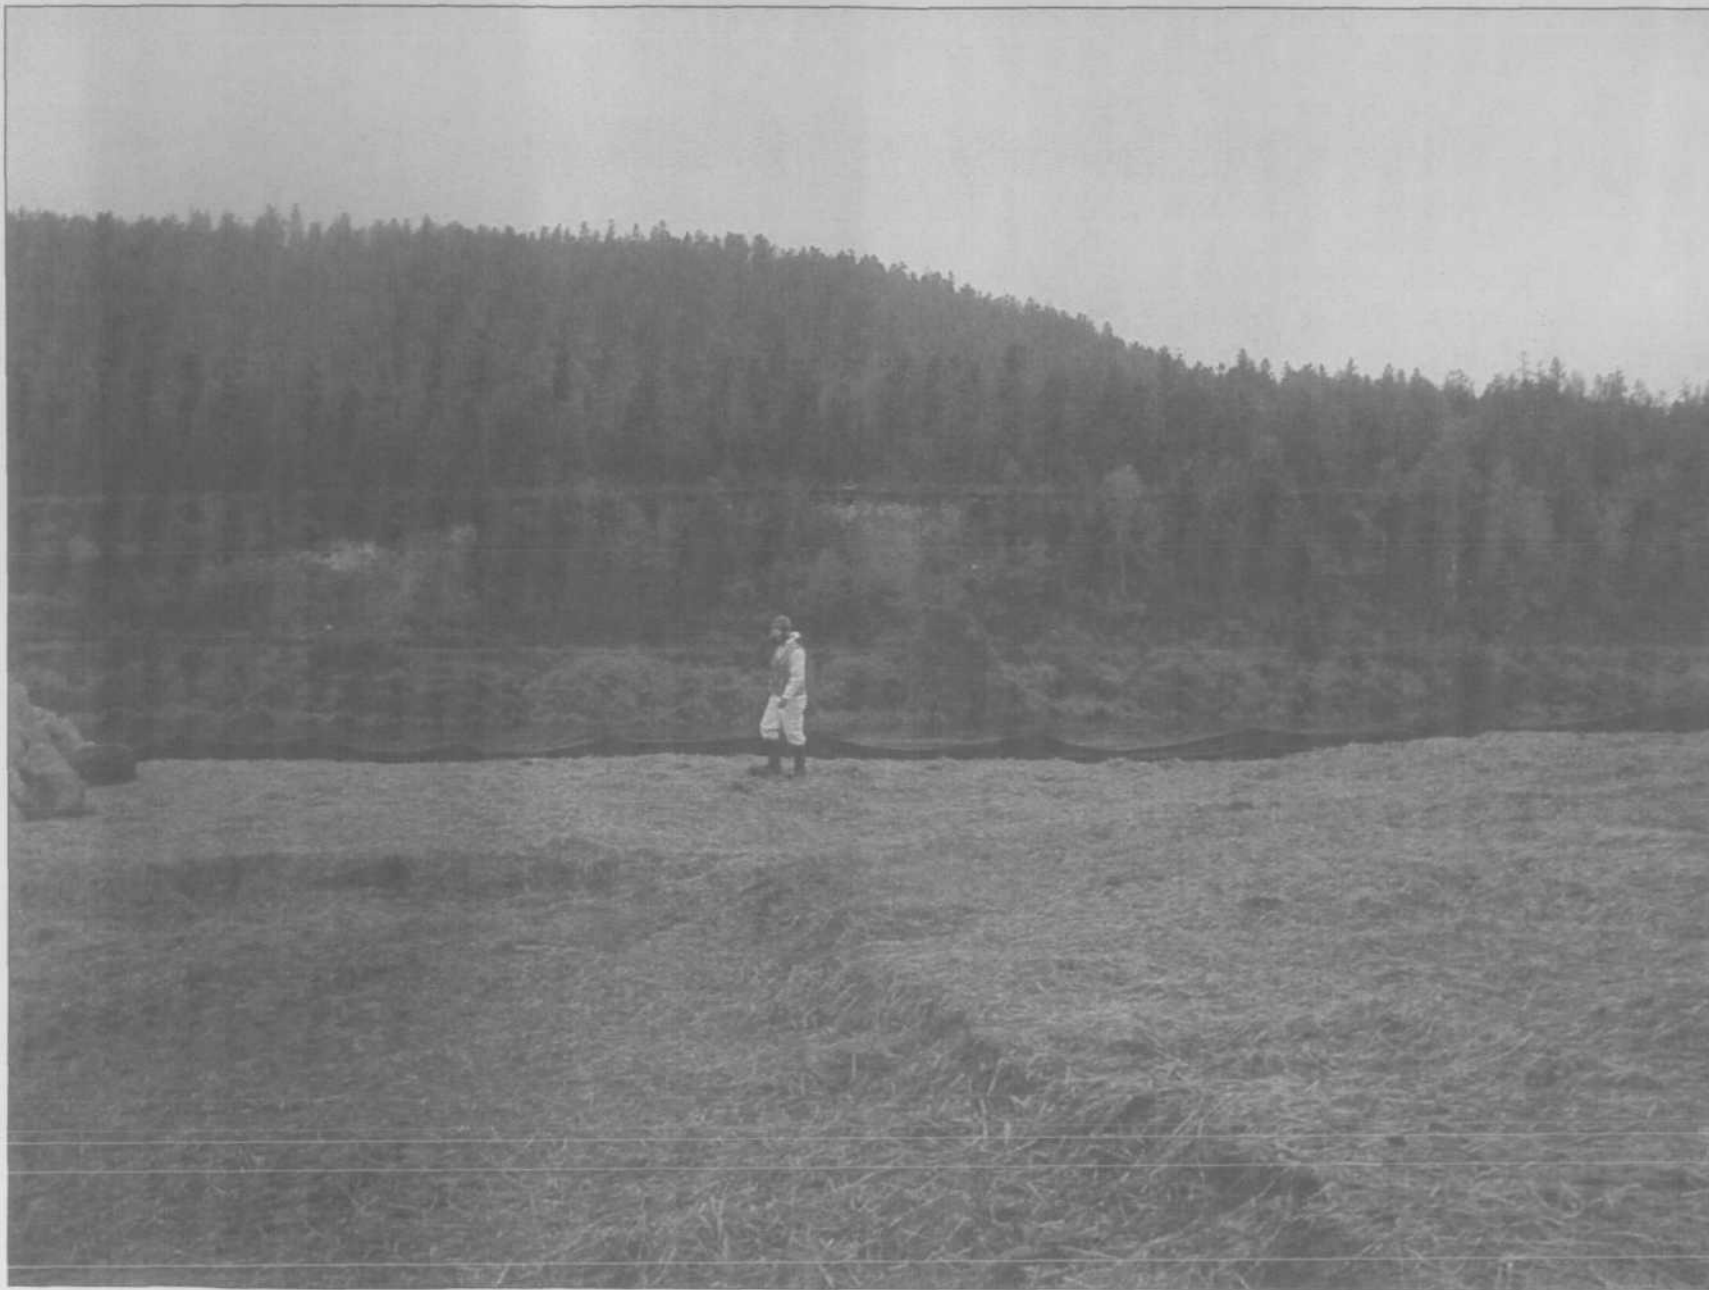
Flyway Site - Excavated Area Ready for Backfill

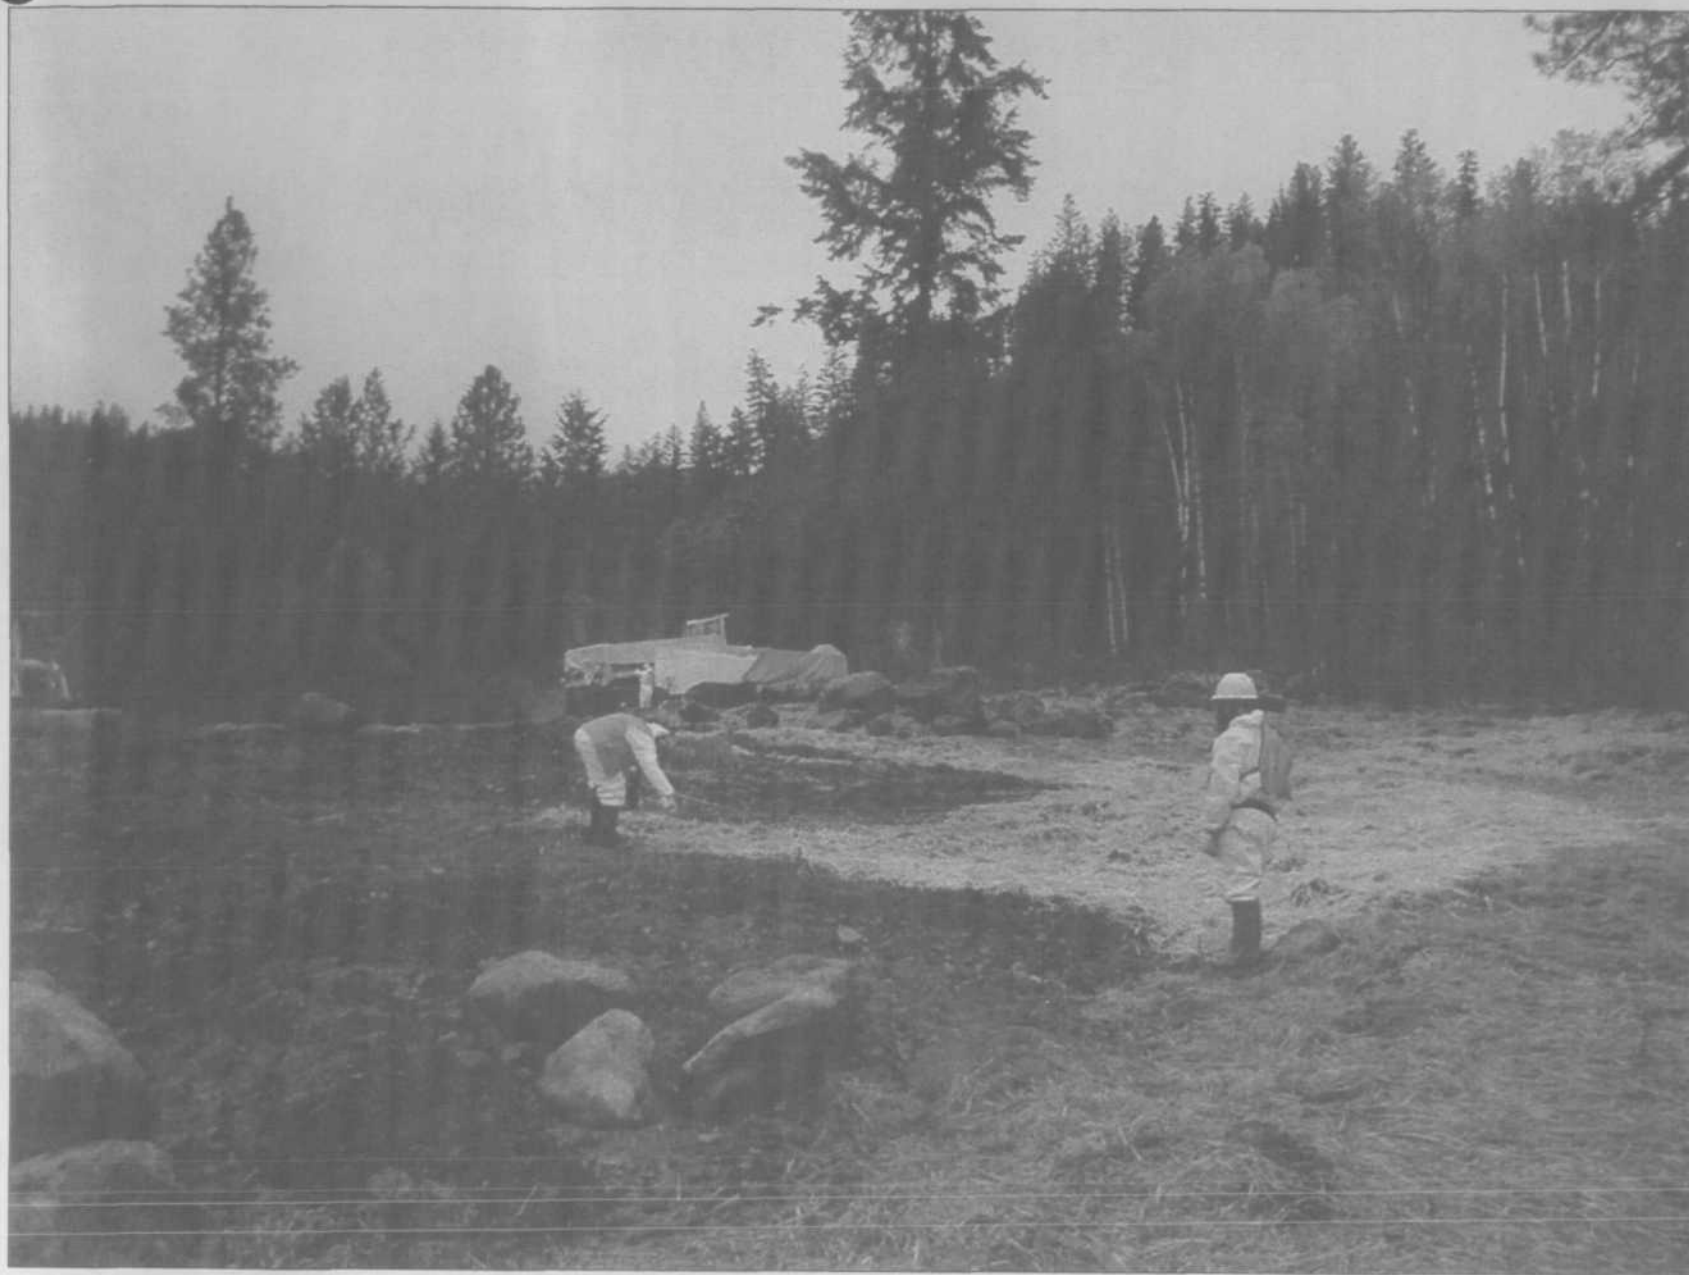
Flyway Site - Measuring and Marking Sub-Grids

A surveyor was used to mark key survey points with wooden stakes. From these points, a measuring tape was used to mark the 100' x 100' grid areas which were staked at the grid corners. In addition, each sub grid (20' x 20') was also identified using a measuring tape and marked with paint.

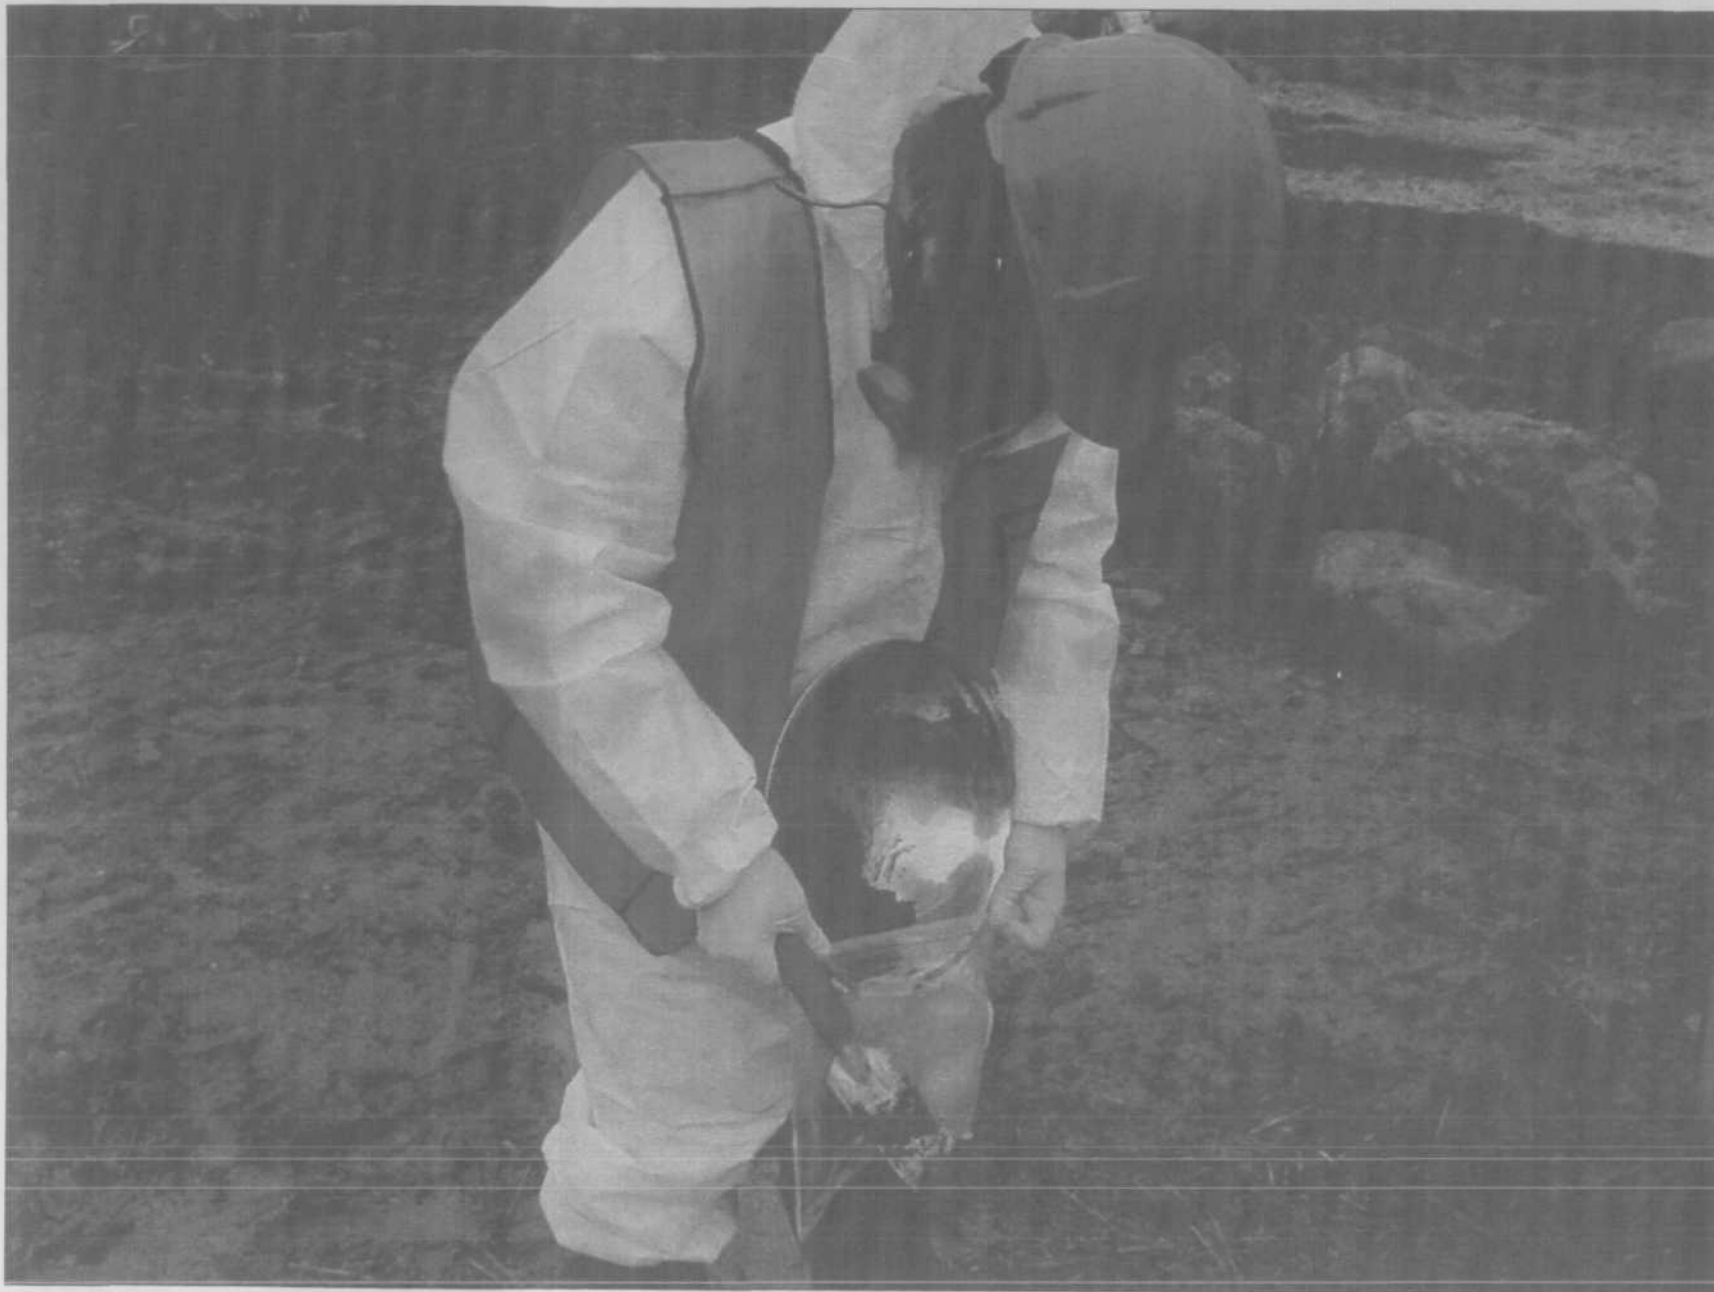
Flyway Site - Collecting Soil Sample

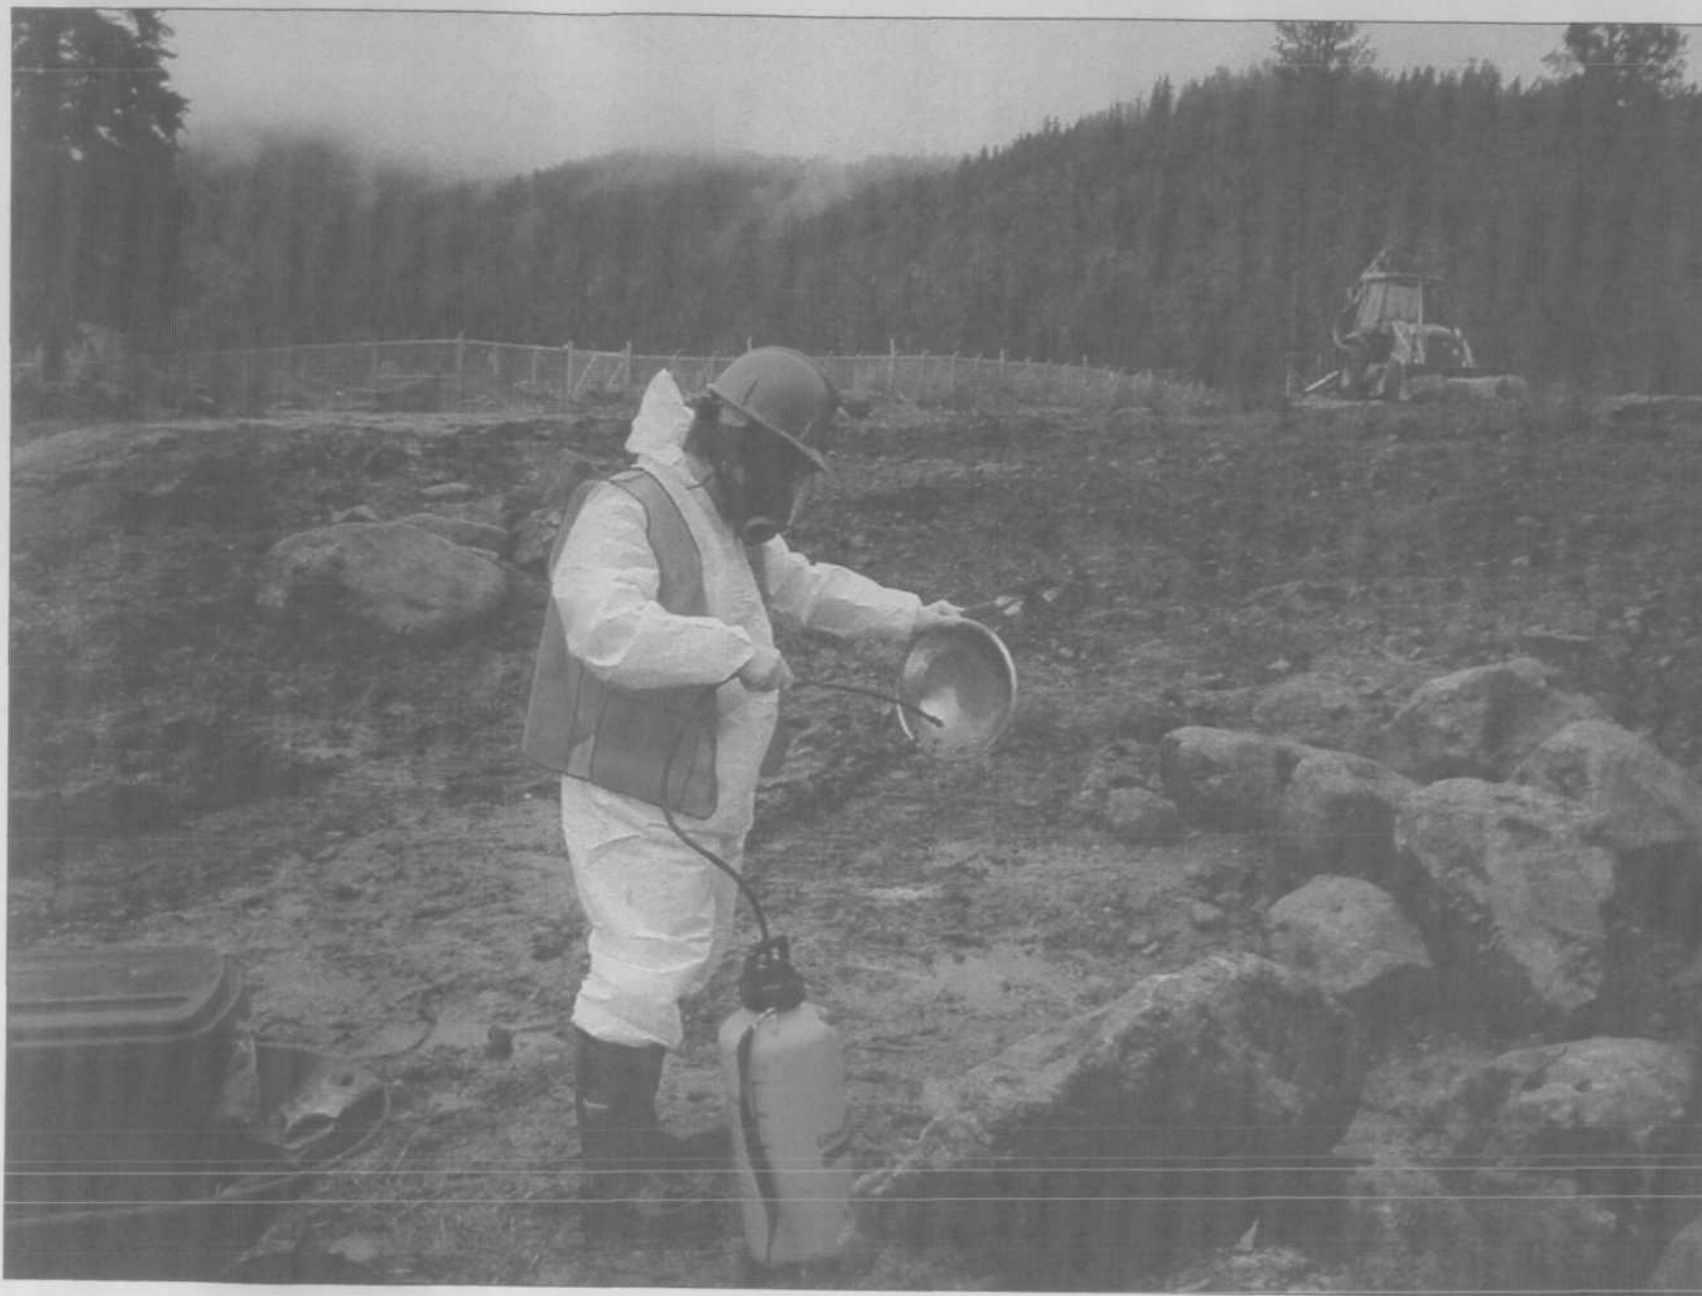
Flyway Site - Decontaminating Sampling Equipment between Samples

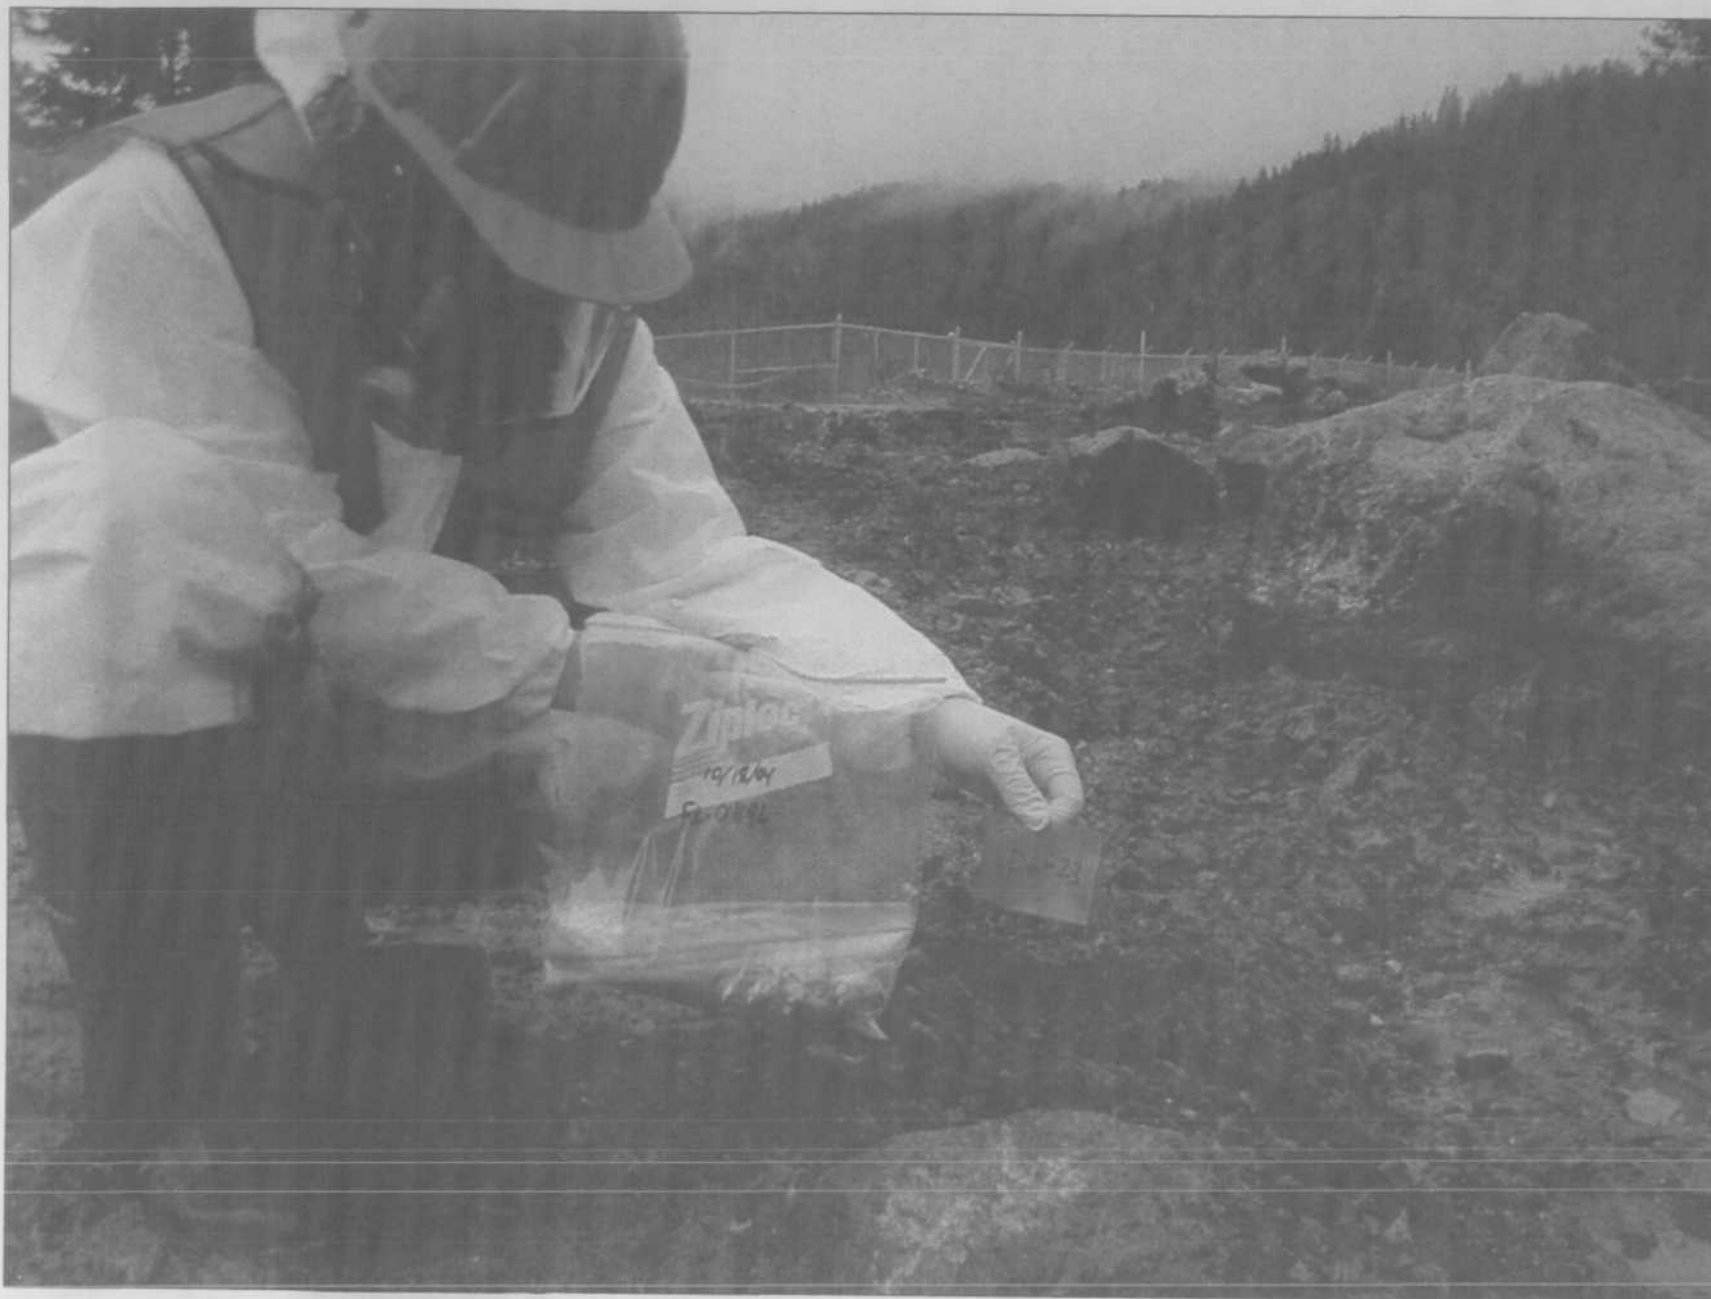
Flyway Site - Verifying Soil Sample Number with Sample Location (Grid # - Sub-Grid #)

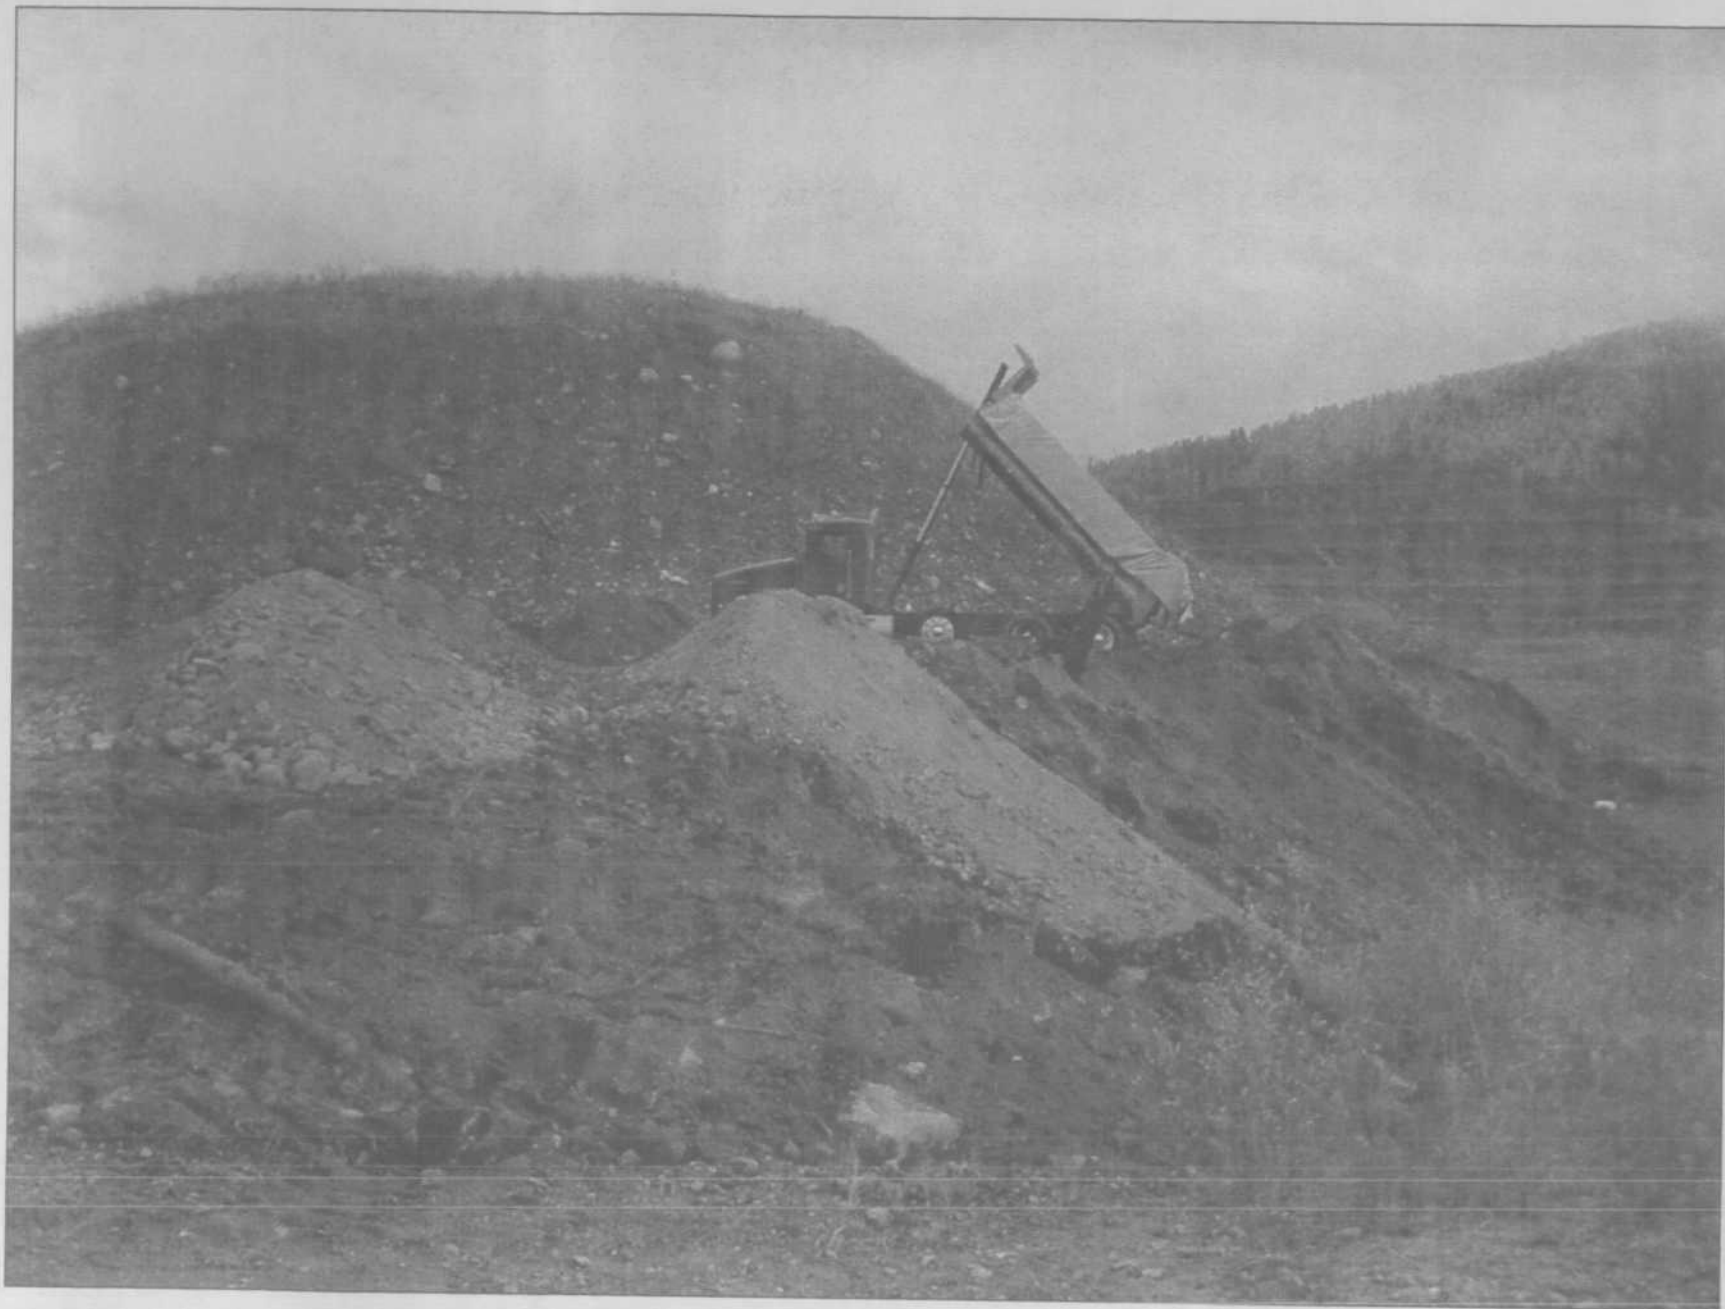
Flyway Site - Dumpsite at the Former Mine

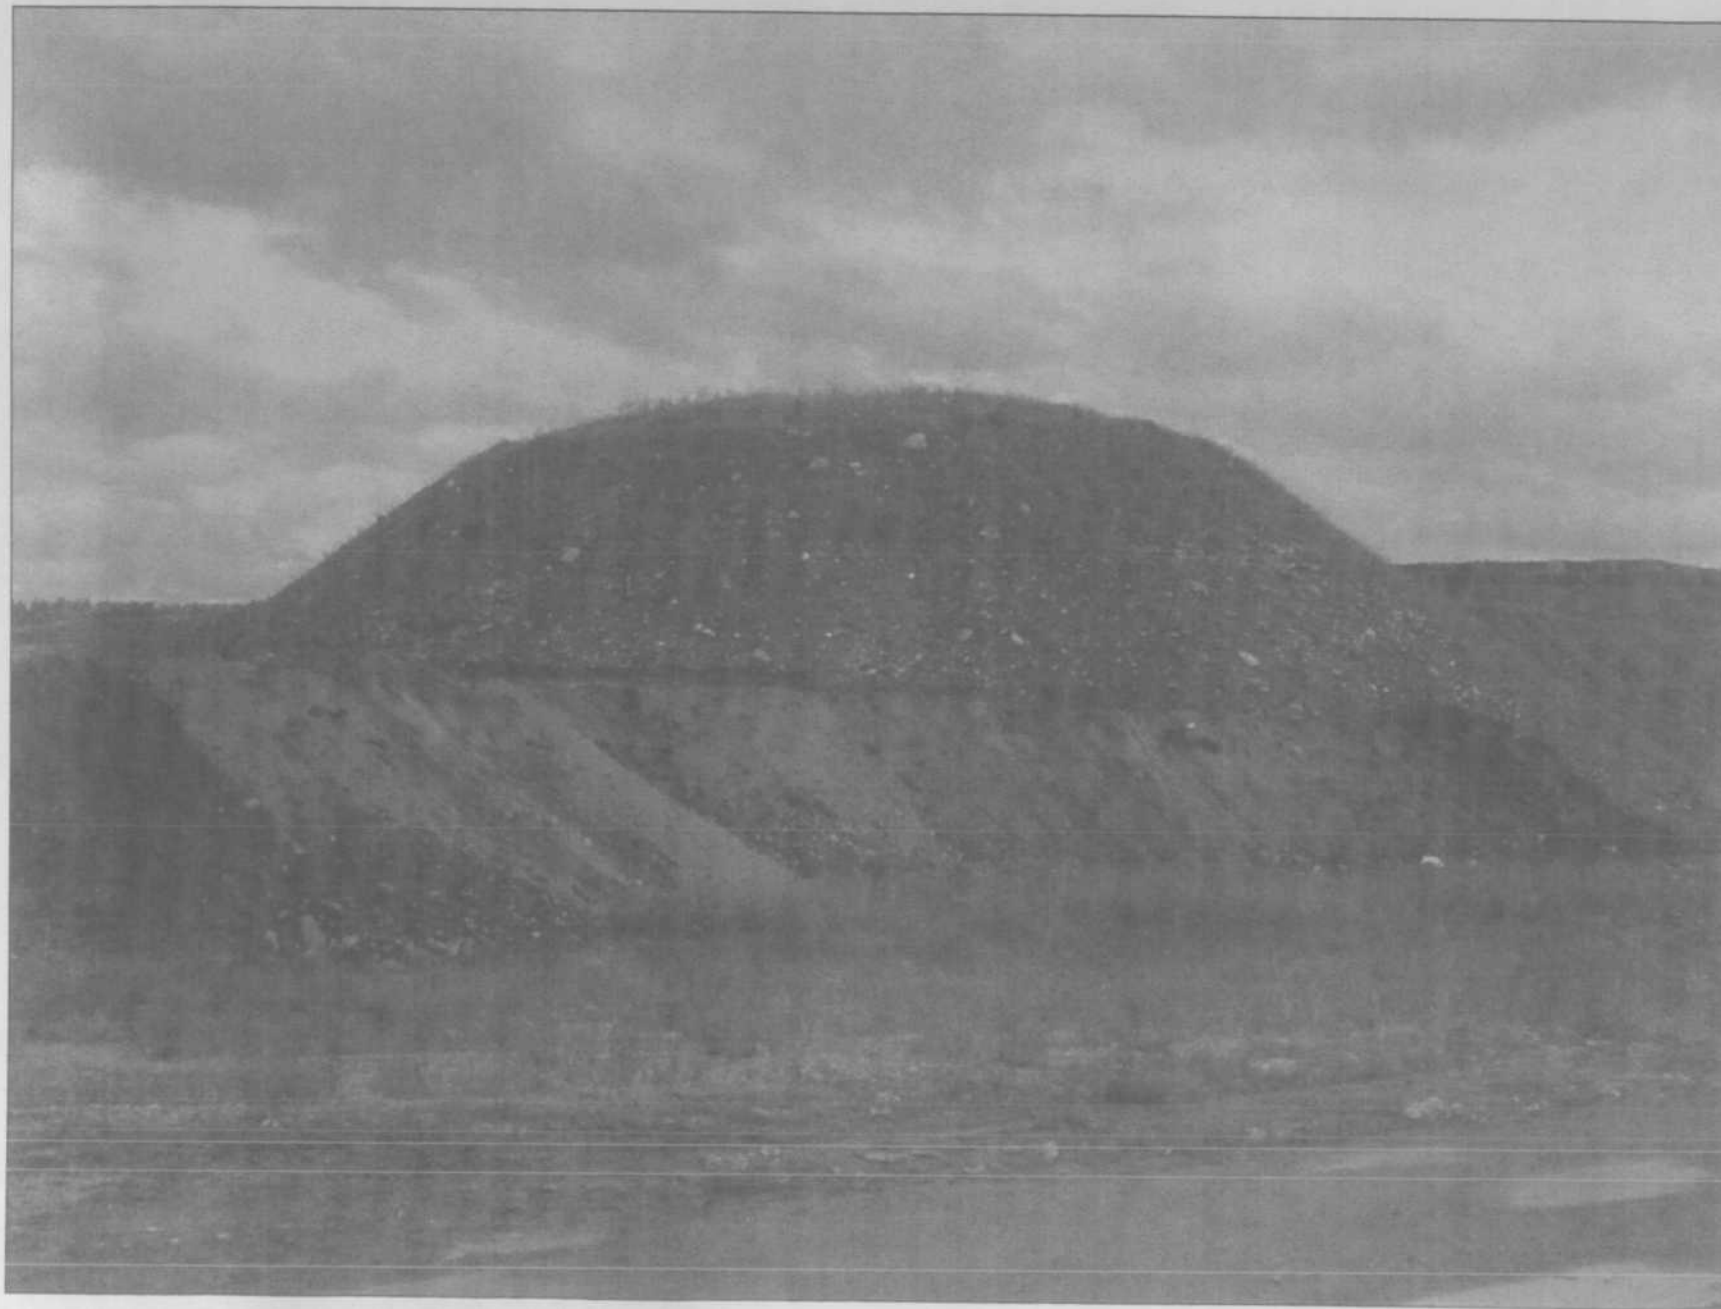
Flyway Site - Leveled Dumpsite at Former Mine

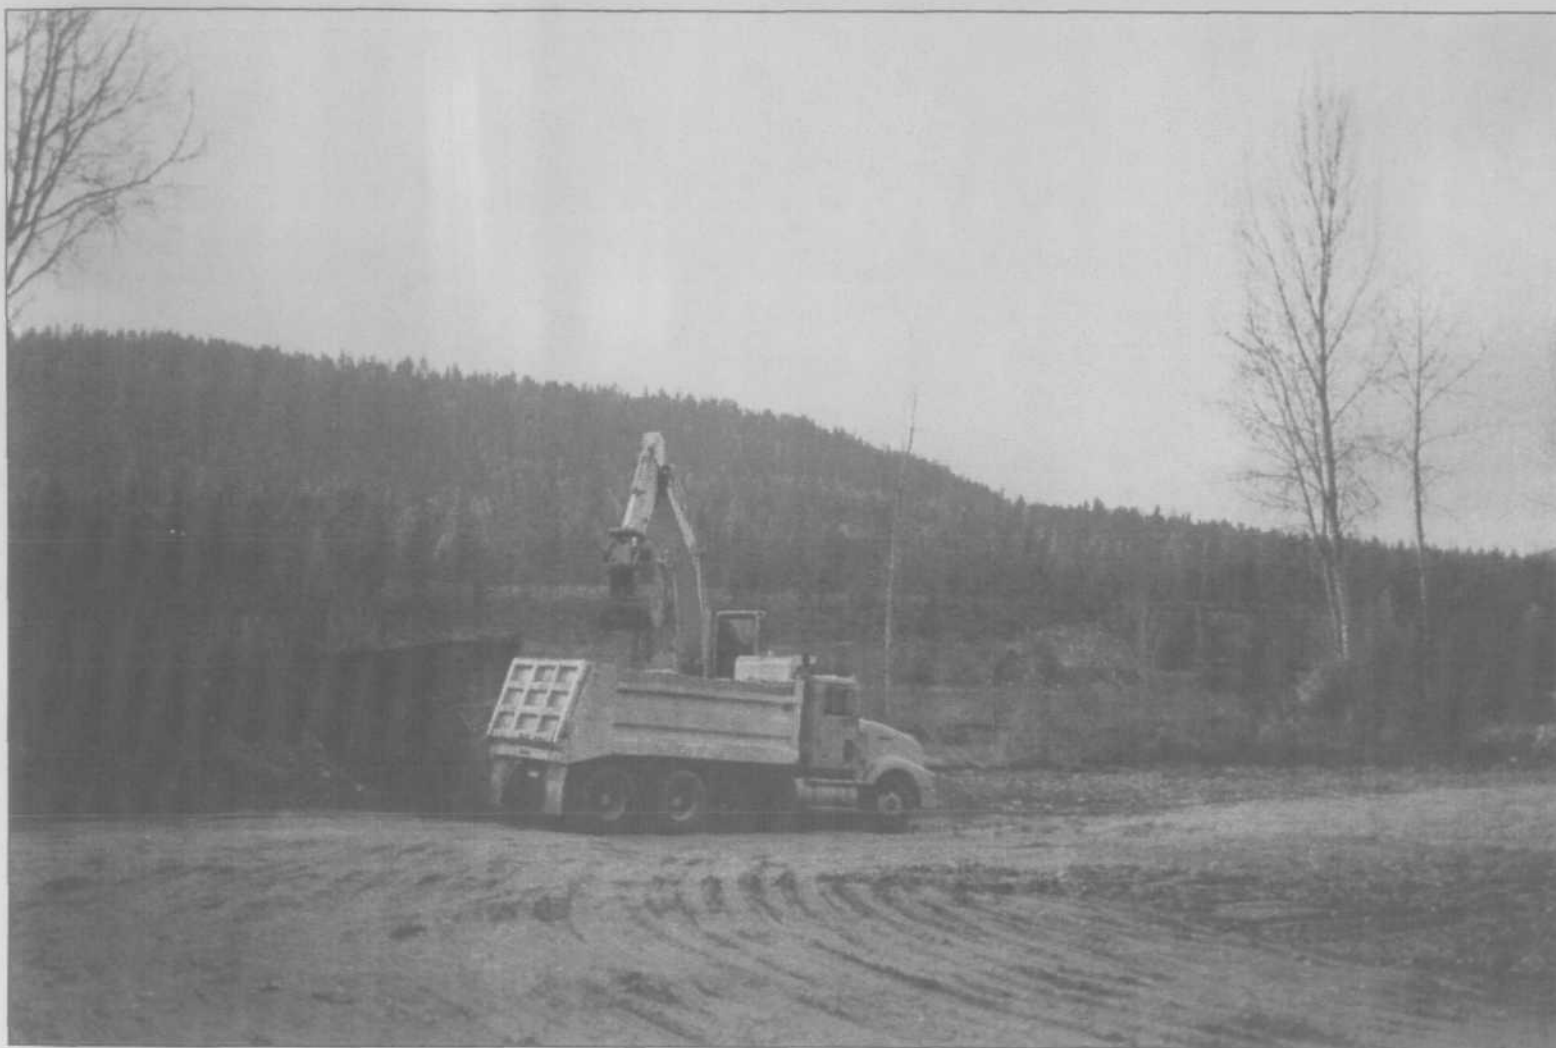
Flyway Site - Loading On-Site Clean Backfill

Backfilling commenced on November 1, 2004. An on-site stockpile of "clean" soil estimated at 10,500 cu. yds. was supplemented with 17,640 cu. yds. (1,764 truck loads) of backfill obtained from the Plum Creek soil/gravel pit in Libby. EPA tested the ^③ Plum Creek material and determined it to be "clean" prior to use as backfill on the Flyway site. An estimated 28,140 cu. yds. of backfill material was used to grade and re-contour the site.
